**CALSPAN ON-SITE INVESTIGATION OF TWO COMPRESSED NATURAL GAS
(CNG) CYLINDER RUPTURES
CALSPAN CASE NOS. 94-19 AND 94-20**

VEHICLES - TWO 1992 GMC SIERRA 2500 PICKUP TRUCKS

**CALSPAN CASE NO. 94-19 AND CASE NO. 94-20
COMPRESSED NATURAL GAS CYLINDER FAILURES
1992 GMC SIERRA 2500 SERIES PICKUP TRUCKS**

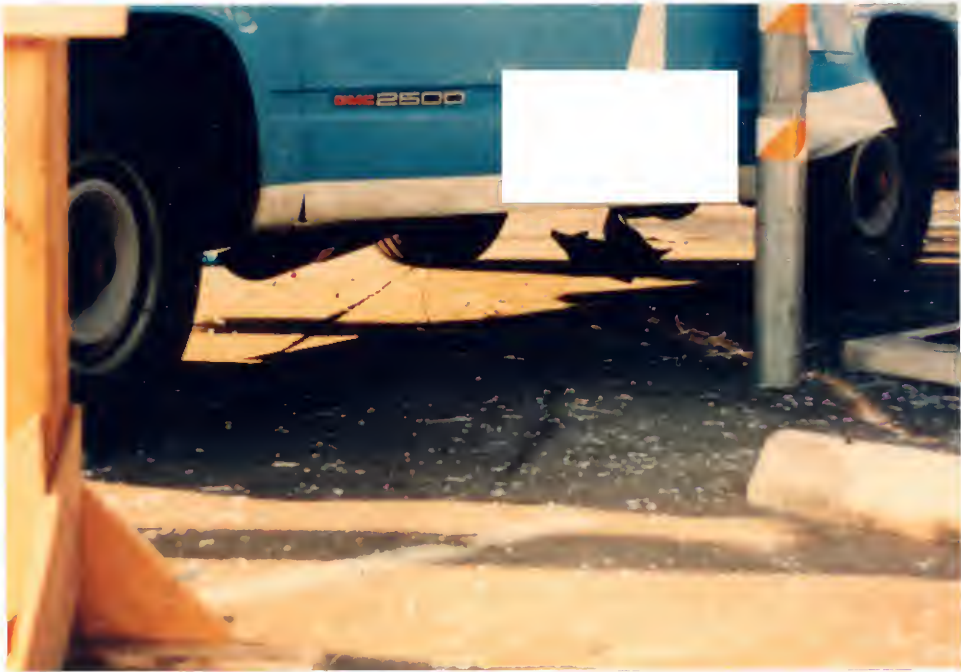
3. View Toward the Left Undercarriage Area of the Pickup Truck

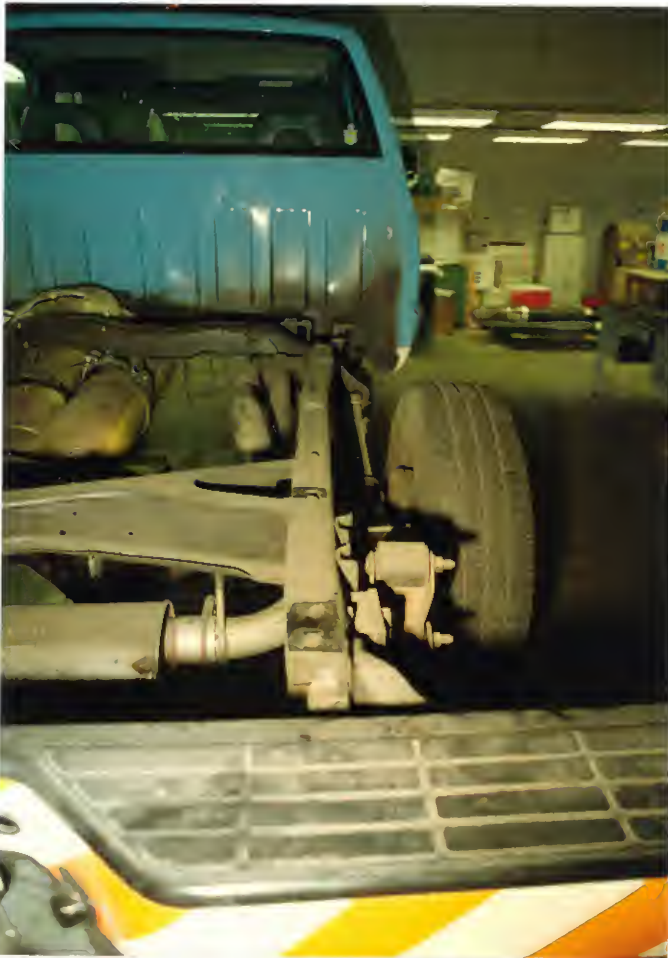
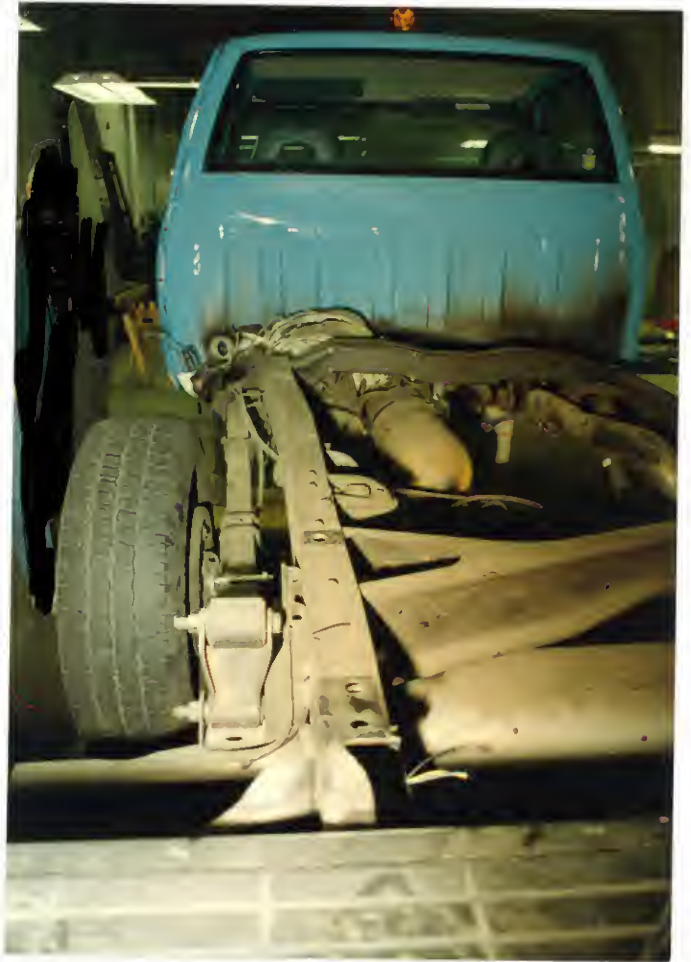
9. Longitudinal View of
the Left Frame Rail

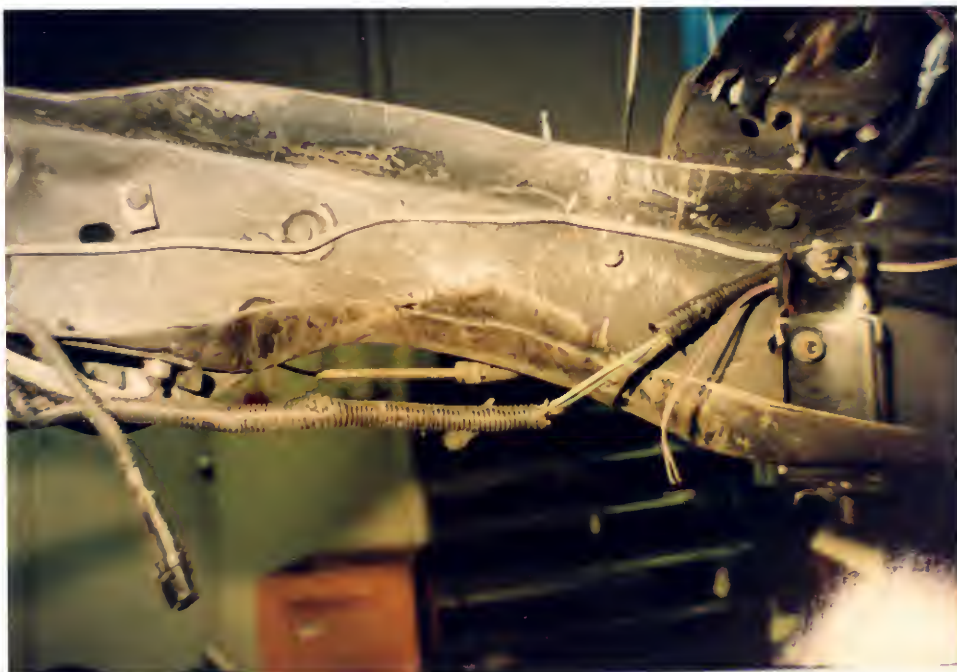
14. Inboard View of the Frame Rail Deformation
with the Cylinder Removed from Vehicle

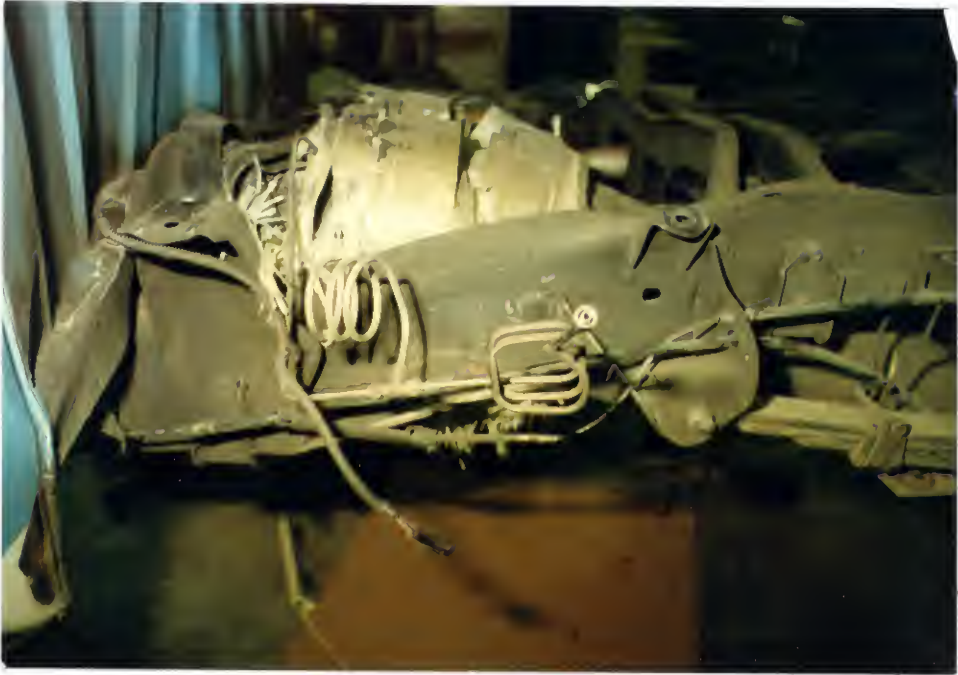
15. Perpendicular Outboard View of the Frame Rail Deflection and Cylinder Wrap Separation

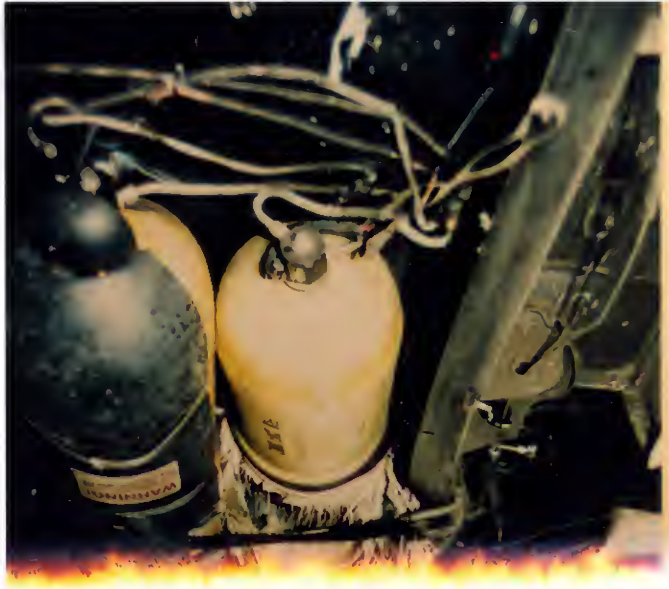
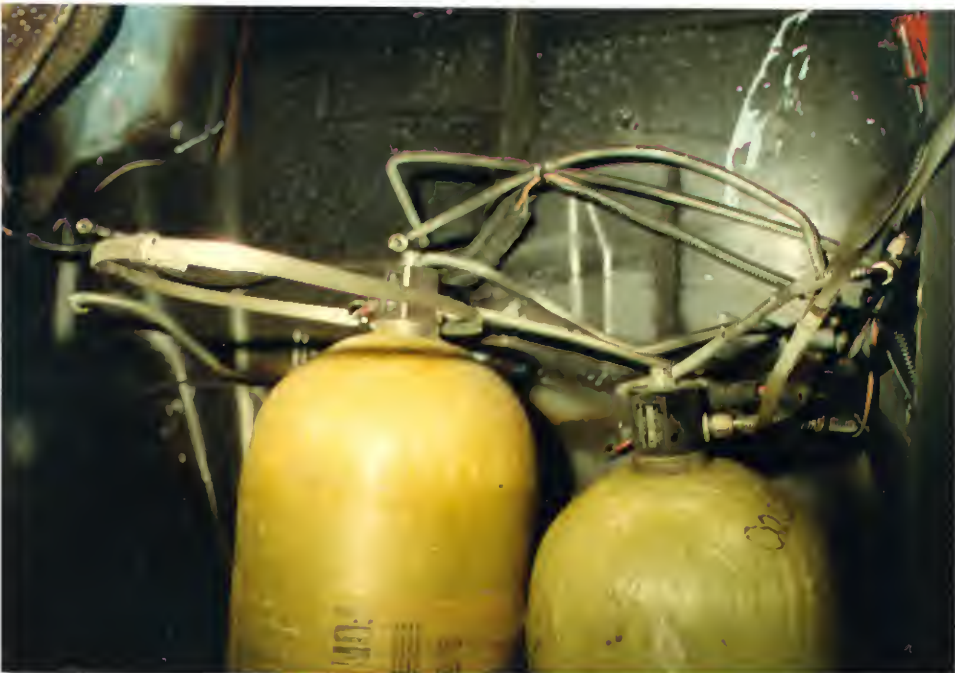
17. Longitudinal View of the Ruptured Cylinder and the Stainless Steel Supply and Delivery Tubing

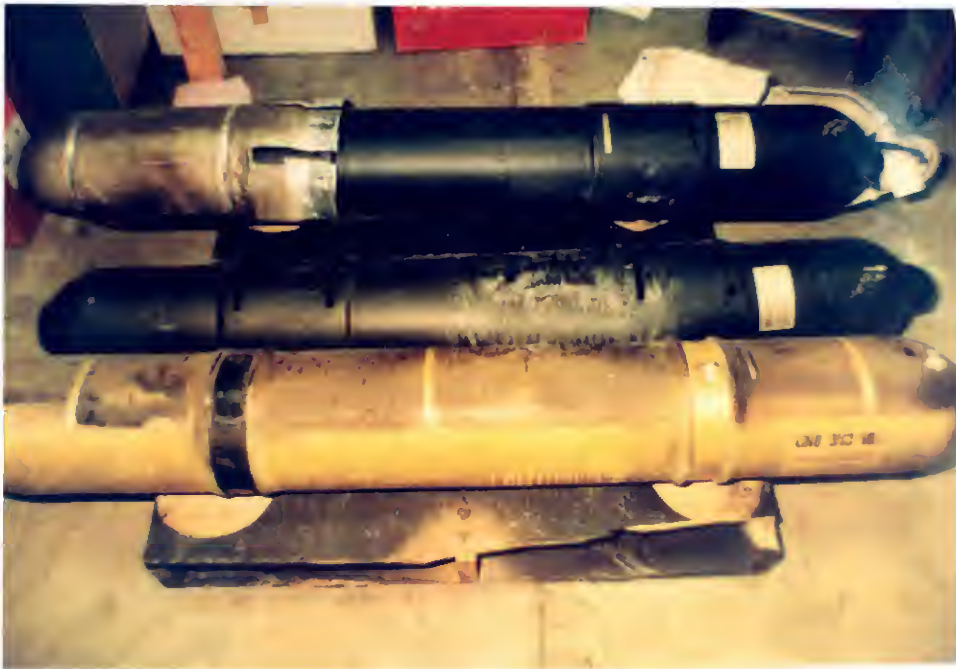
27. Removed Center and Right Cylinders and the Respective HDPE Shields

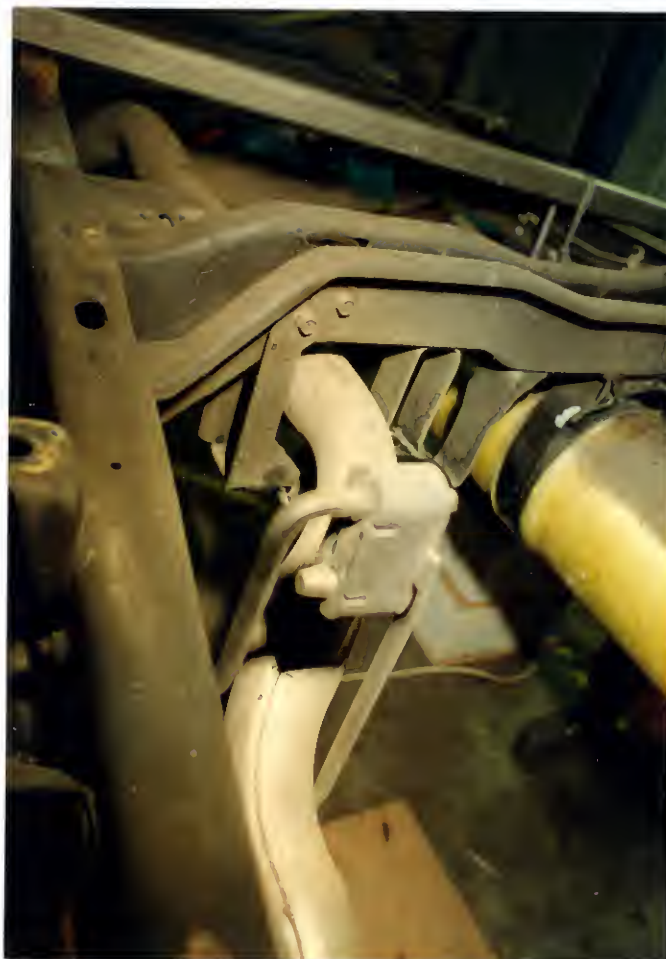
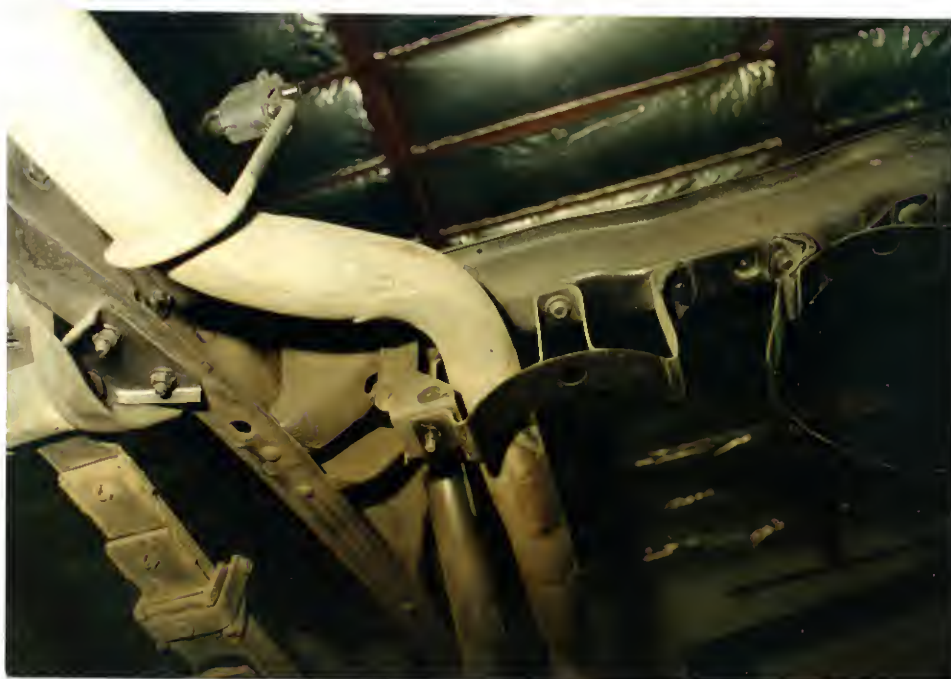
28. Brake Cable Rub Mark on the Rear of the Ruptured Cylinder

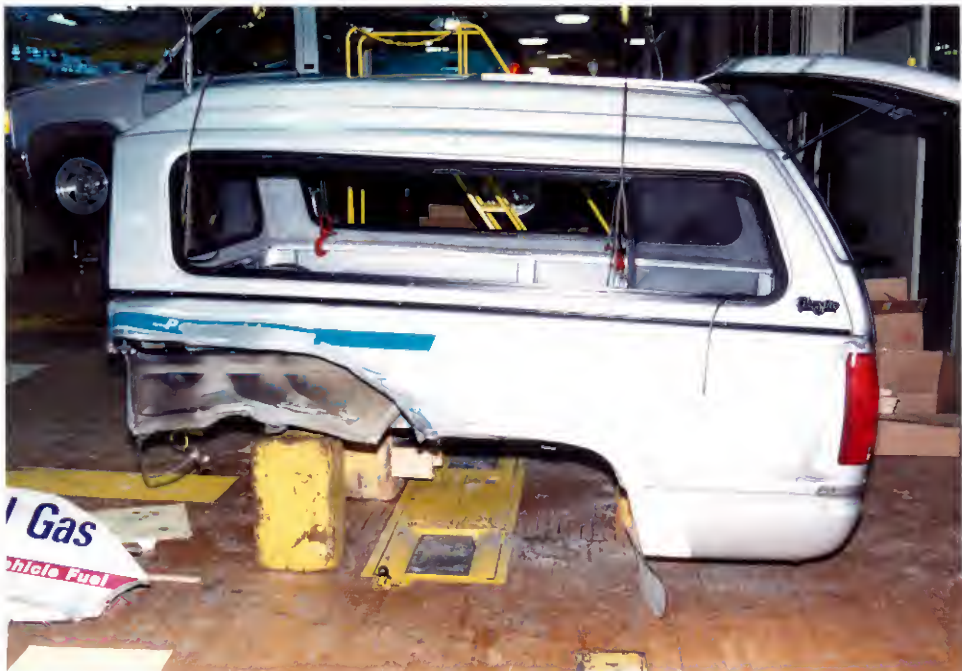
7. View of the left side of the cargo bed and cargo cap

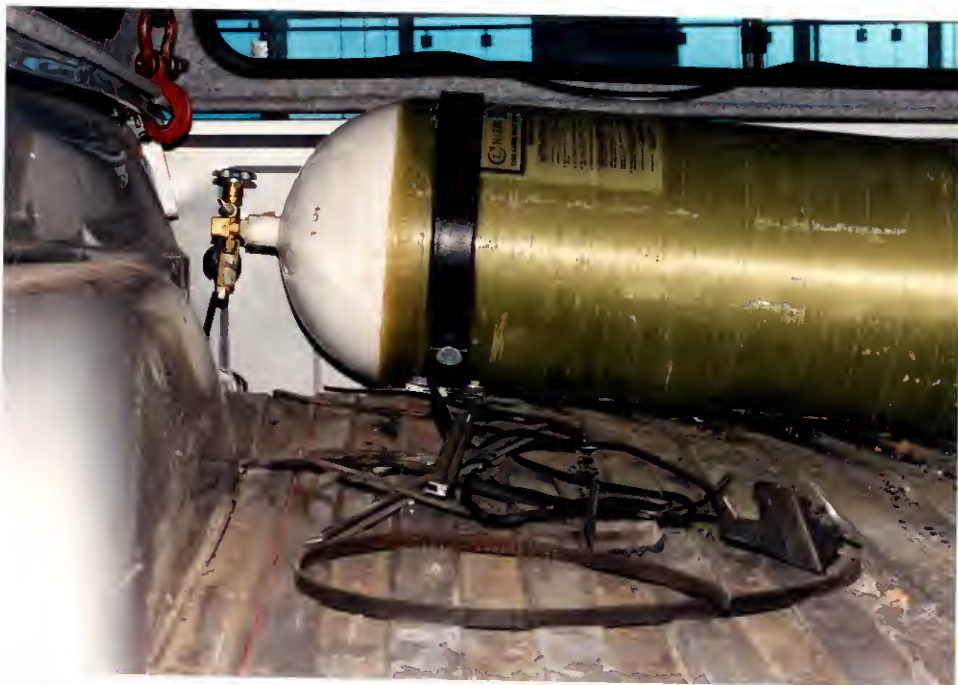
12. Close-up view of the add-on tank and the upward deformation of the cargo box floor

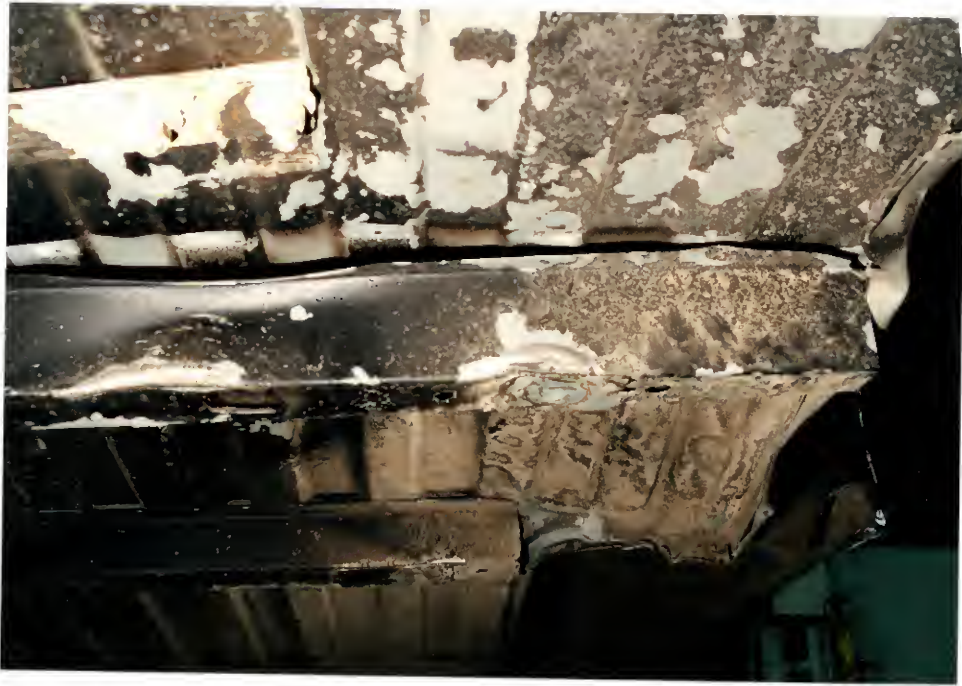
17. Close-up view of the cargo bed looking from front to back along the left side in the area over the failed CNG tank

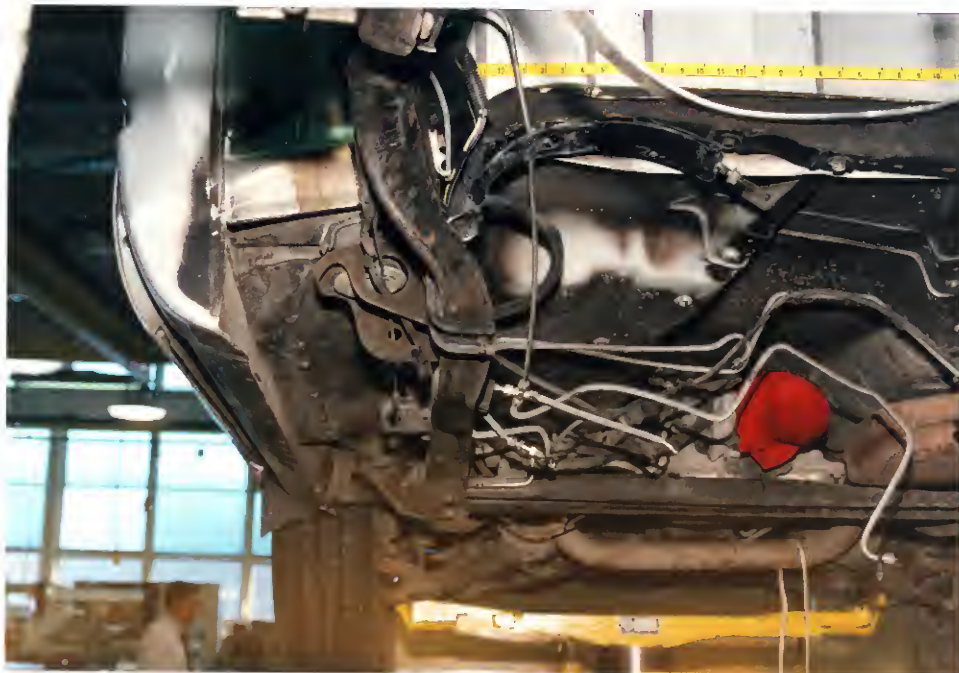
24. View of the left frame rail showing the lateral displacement from underneath the vehicle

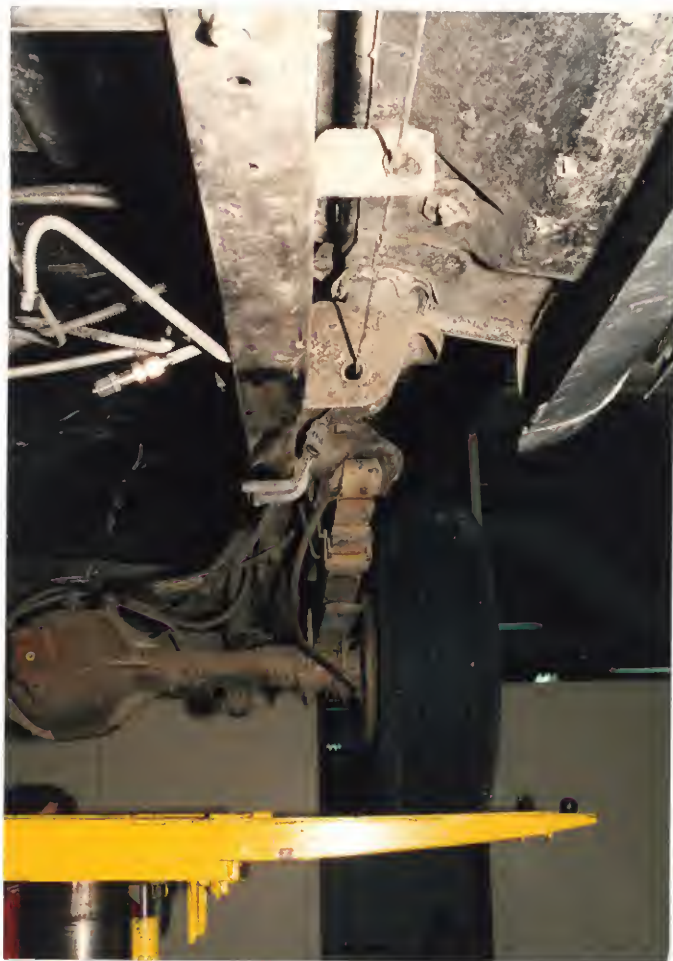
27. View of the left frame rail from underneath looking from the area of the fuel line plumbing rearward

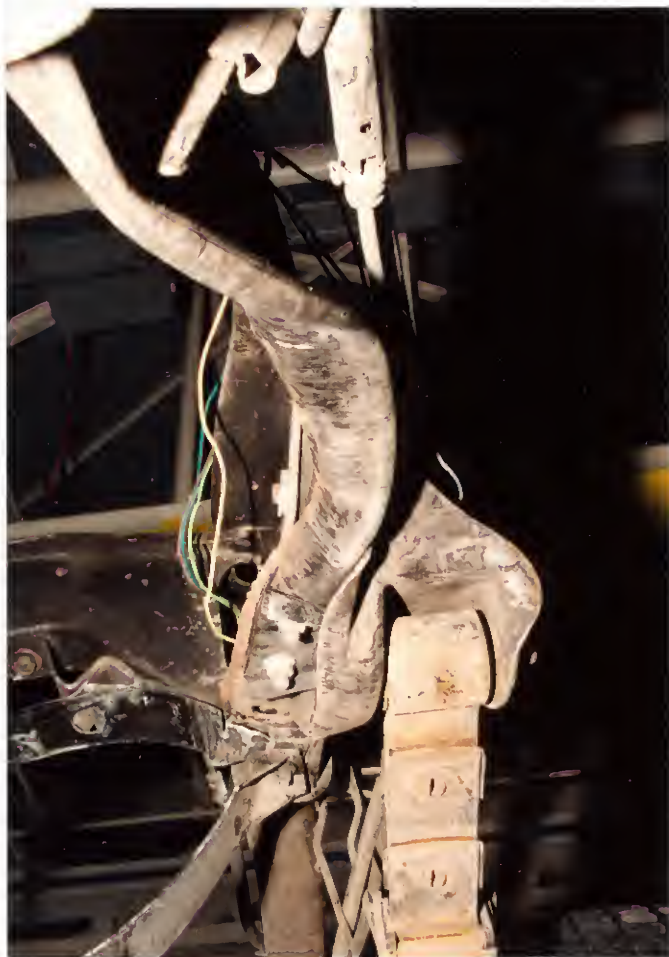
28. View of the left frame rail from underneath showing the lateral outward displacement resulting from the CNG tank failure

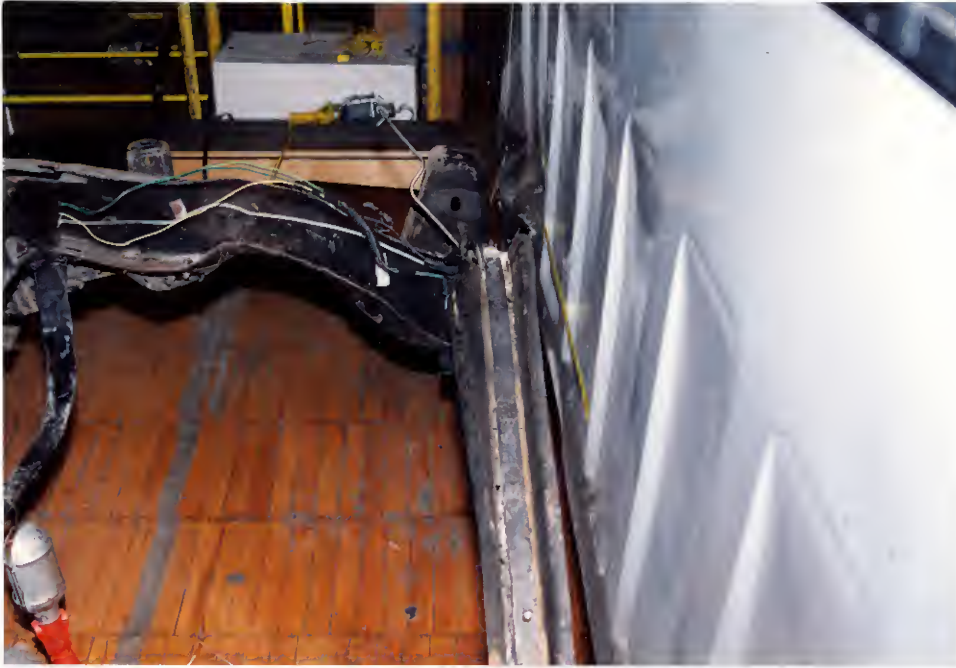
31. Lateral view of the left frame rail from the right side of the vehicle with the rear surface of the cab along the right side of the photograph

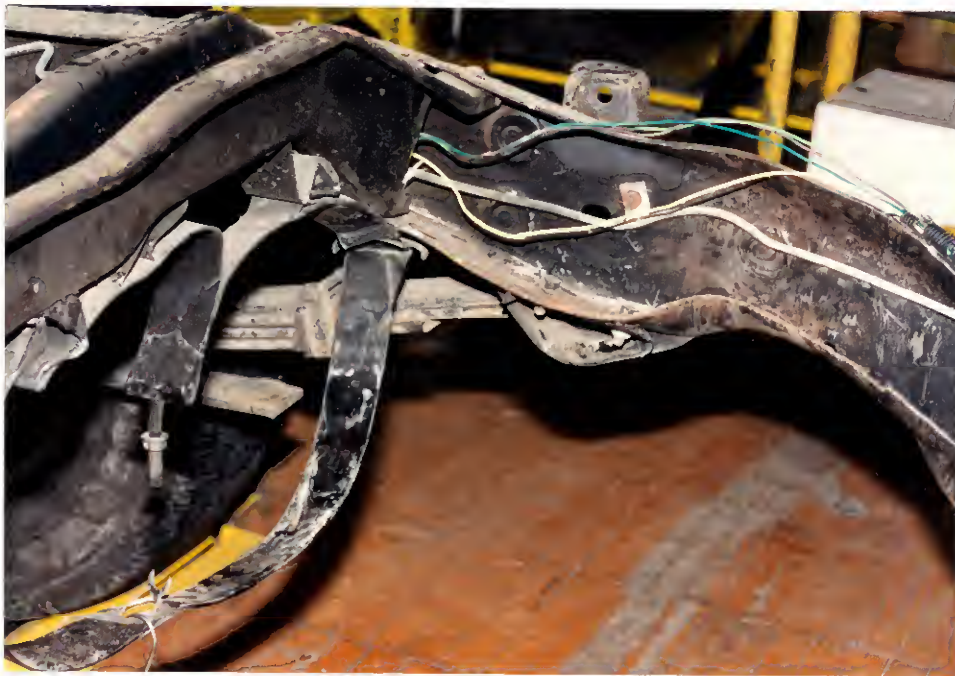
34. Angular view of the left frame rail and the rear tank strap looking from the right side

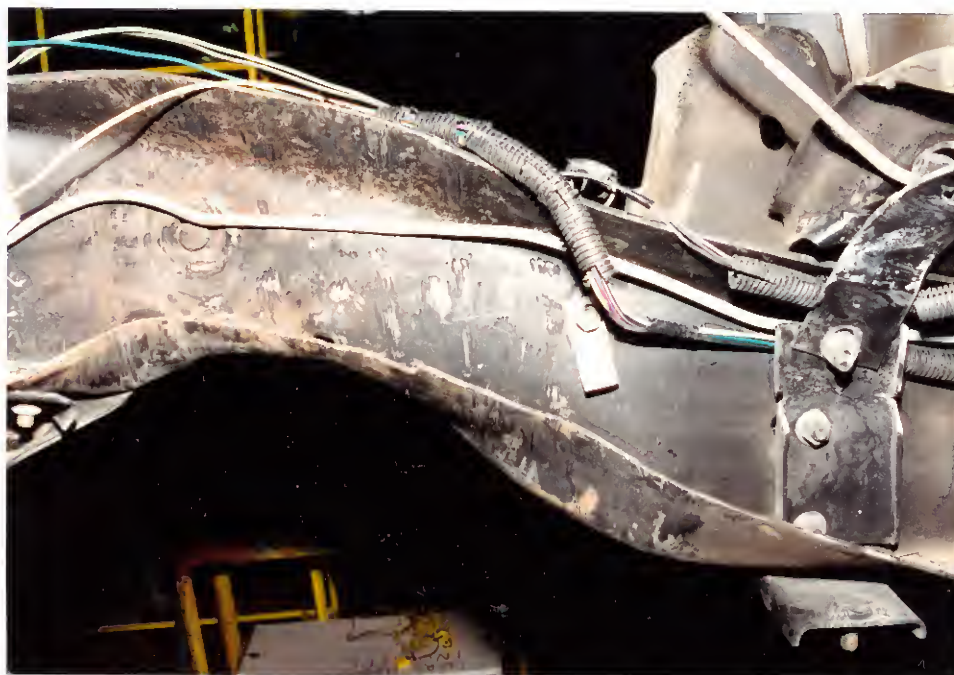
36. View of the left frame rail in the area adjacent to the site of the CNG tank failure

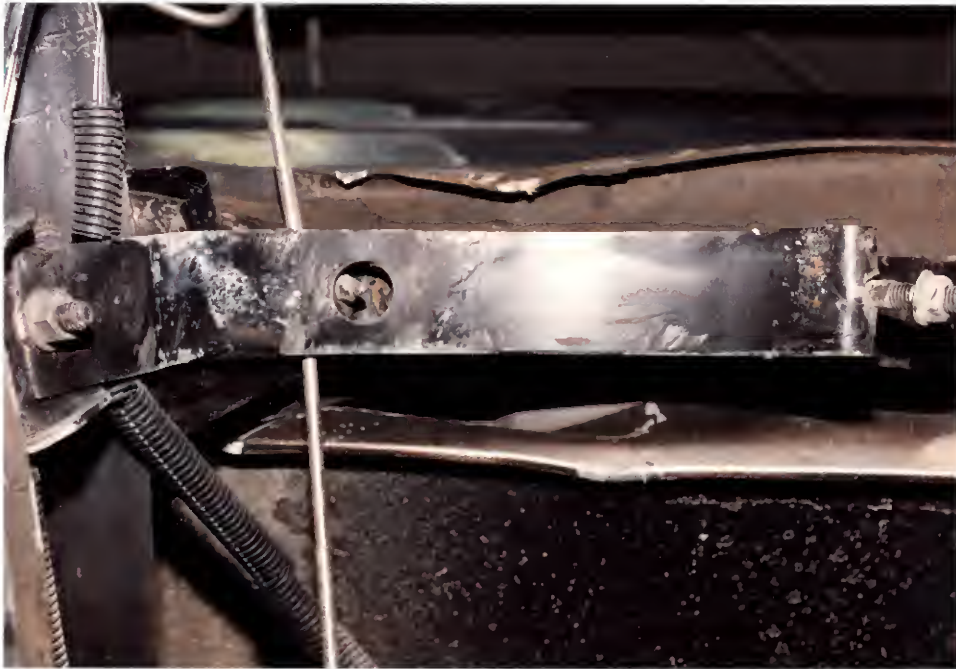
37. View of the forward strap of the failed CNG tank from underneath and looking toward the front of the vehicle along the bottom of the photograph

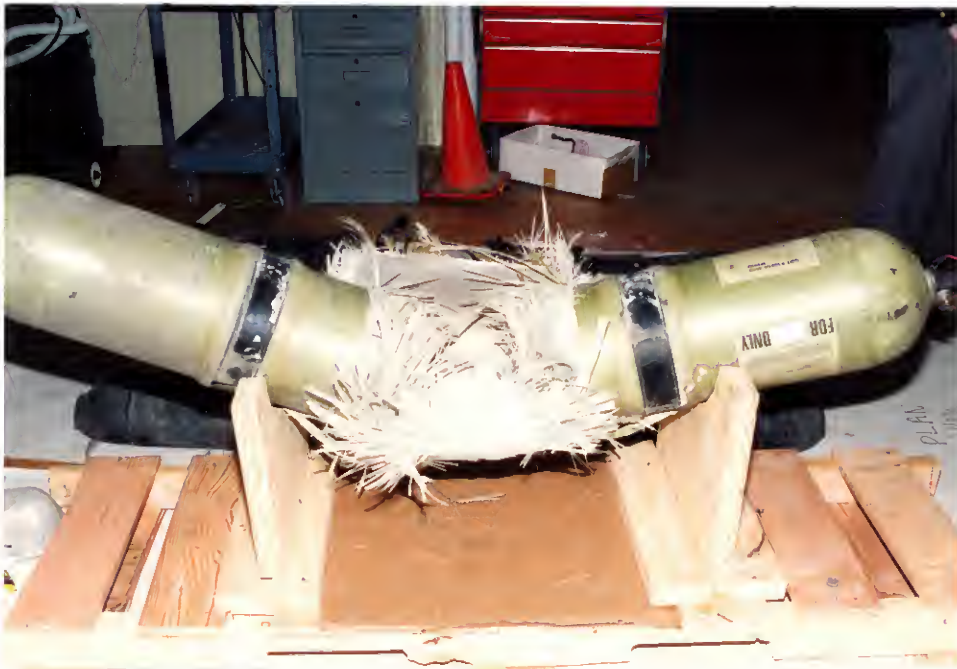
38. View of the failed CNG tank with the bottom of the tank as mounted in the vehicle shown facing up in the photograph and the forward end along the right side of the photograph

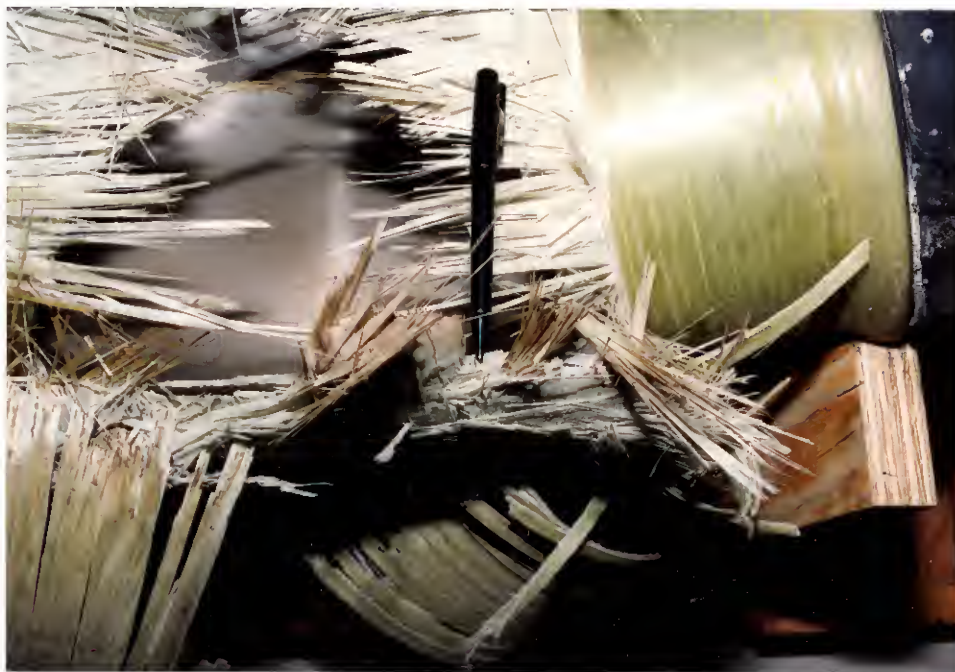
42. Overhead view of the right bottom side of the tank showing the edge of the aluminum tank and composite wrap with the forward end of the tank along the left side of the photograph

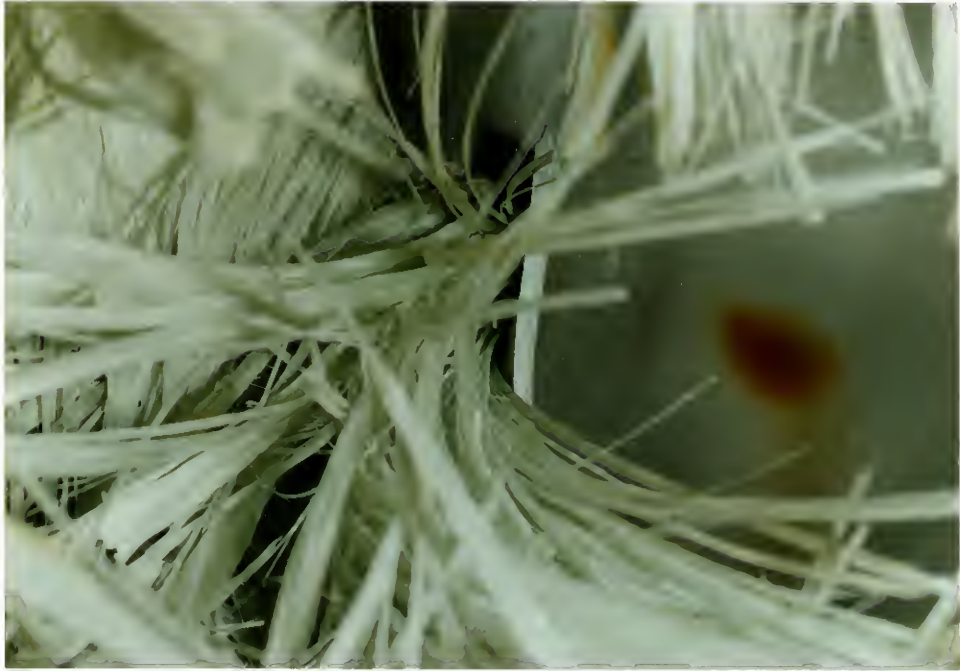
45. Close-up view of the left side of the tank with the forward end of the tank along the top of the photograph

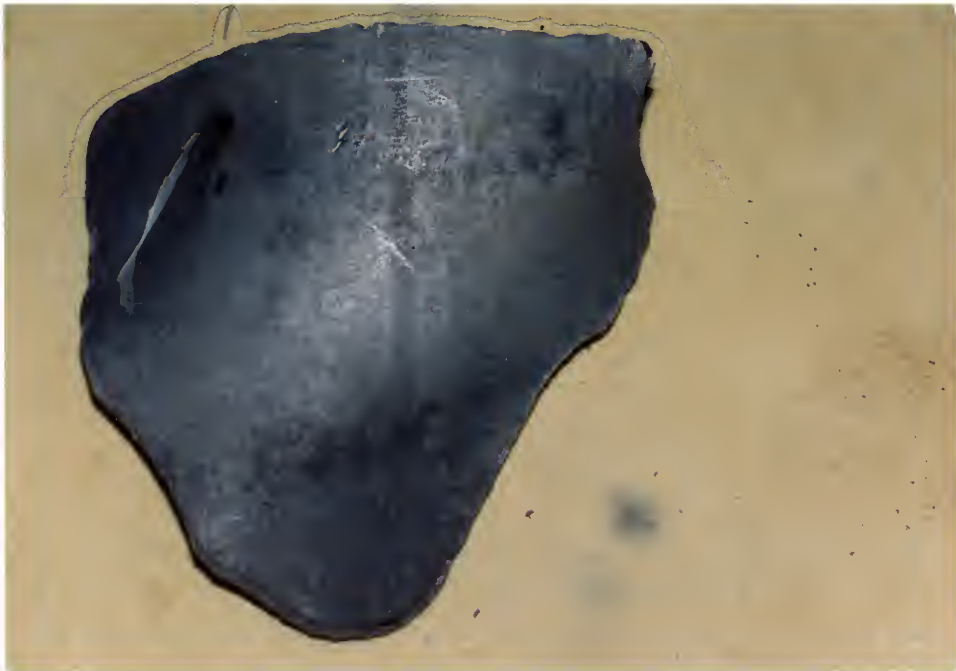
48. View of a fragment from the bottom left side of the aluminum CNG tank

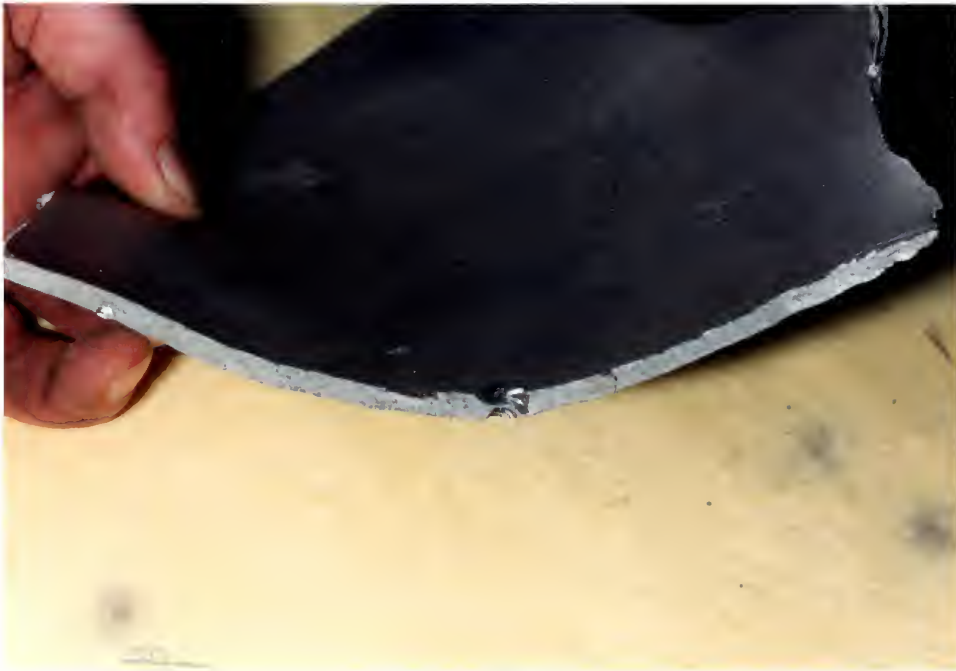
49. Close-up view of the edge of the aluminum tank fragment

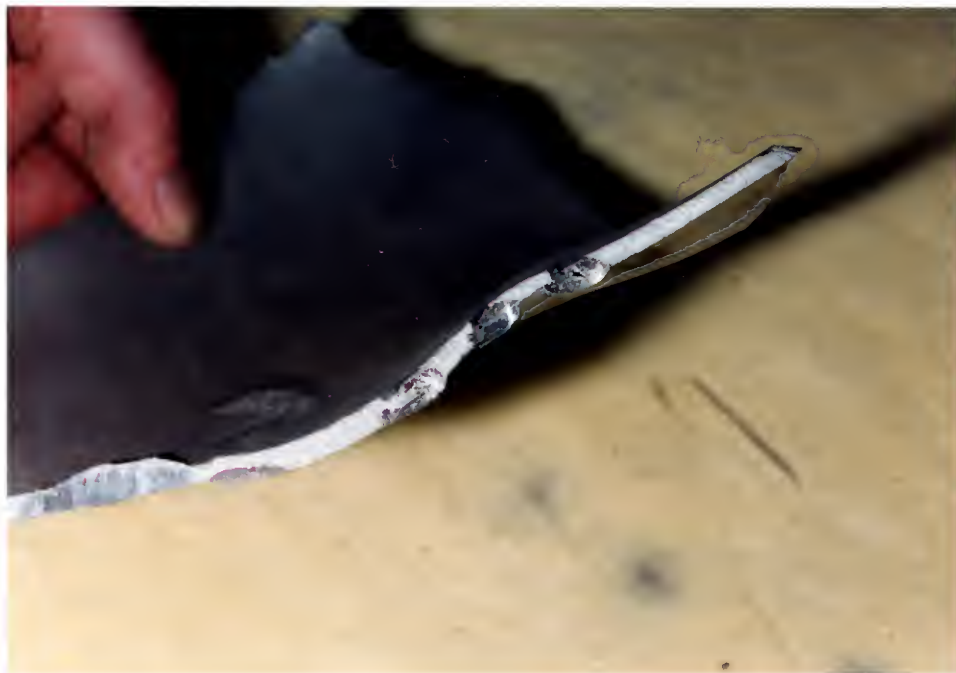
50. Another close-up view of the edge of the aluminum tank fragment

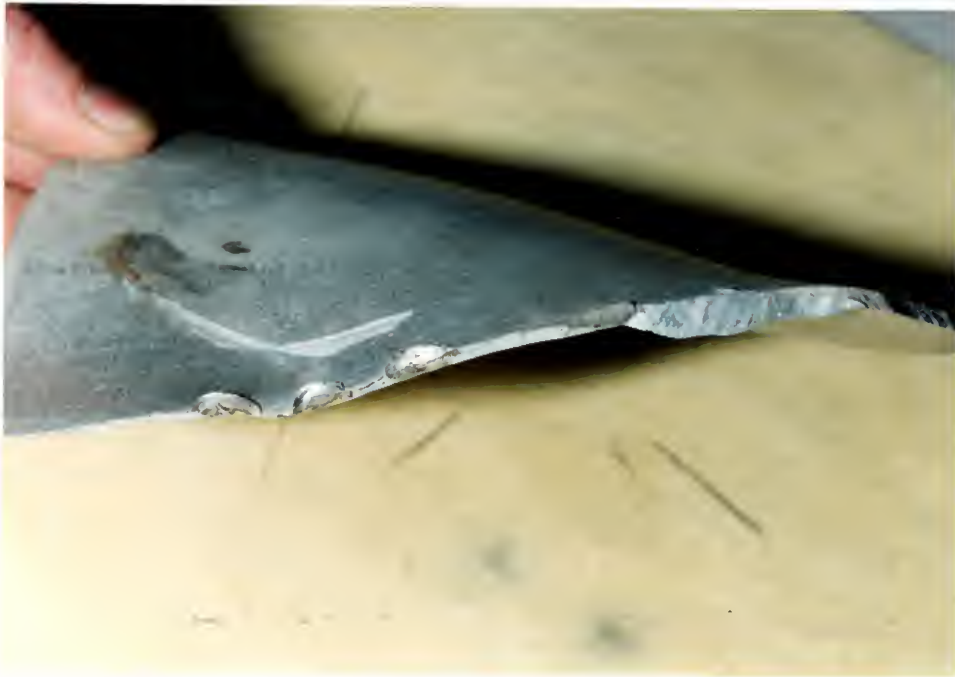
51. Another close-up view of the edge of the aluminum tank fragment

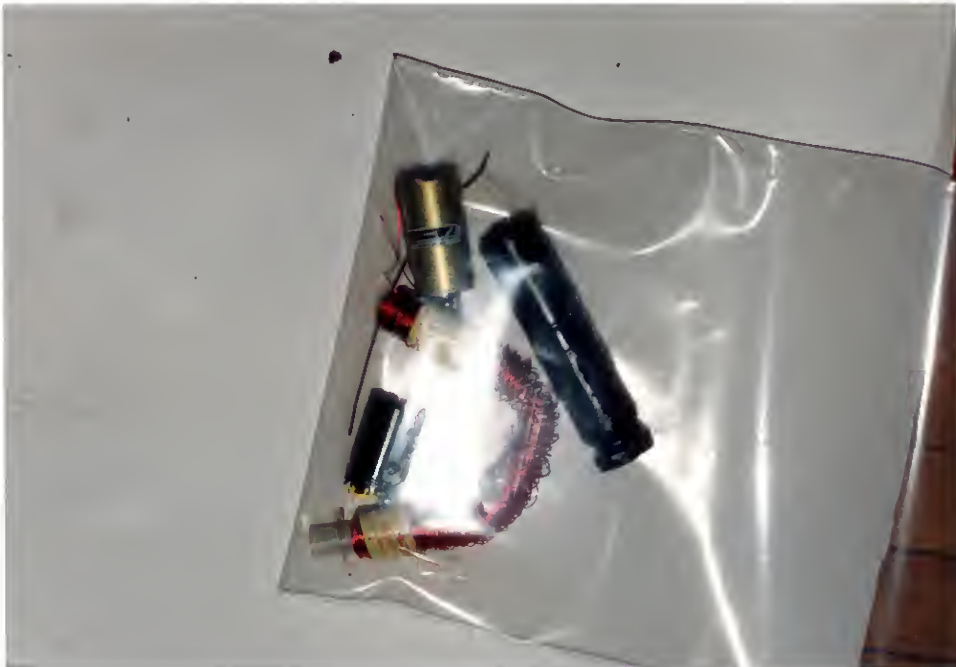
52. View of internal valve components of the failed CNG tank
